A Report for
National Association of Broadcasters
Regarding
High-VHF Field Measurements of
ATSC 3.0 Digital Television Signals
in Cleveland, Ohio

October 25, 2016

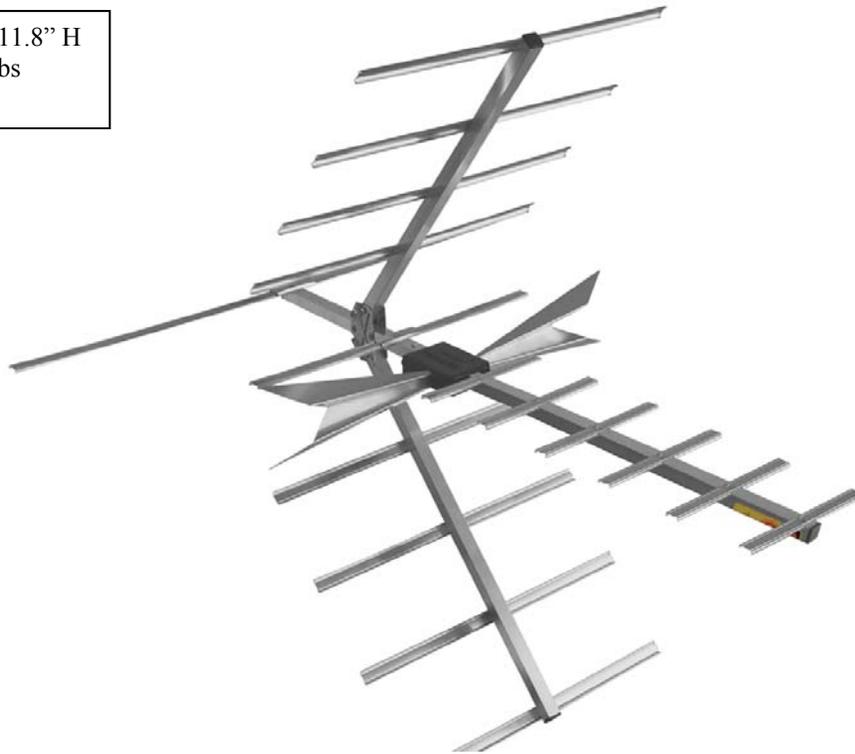
21" L x 33" W x 11.8" H
Net Weight: 1.8 lbs
G ≈ 2.1 dBd

Figure A2-3a Digitenna **DUV-S** VHF/UHF directional receive antenna used in outdoor field test.

Prior to the start of the measurement tests, the forward gain of *each* consumer receive antenna (DUV-S and DUV-I) were calibrated once at 30’ AGL at a location with open space in order to minimize ground reflections. Both the directional (**DUV-S** for 30’ AGL measurements) and the bi-directional (**DUV-I** for indoor measurements) antennas were measured at CH 9 against a reference half-wave VHF dipole antenna also positioned at 30’ AGL for the most accurate calibration results (i.e., with minimal ground clutter/reflections). However, it should be noted that the Cleveland field test only used a horizontally-polarized transmit signal, i.e., a signal with no vertical component.

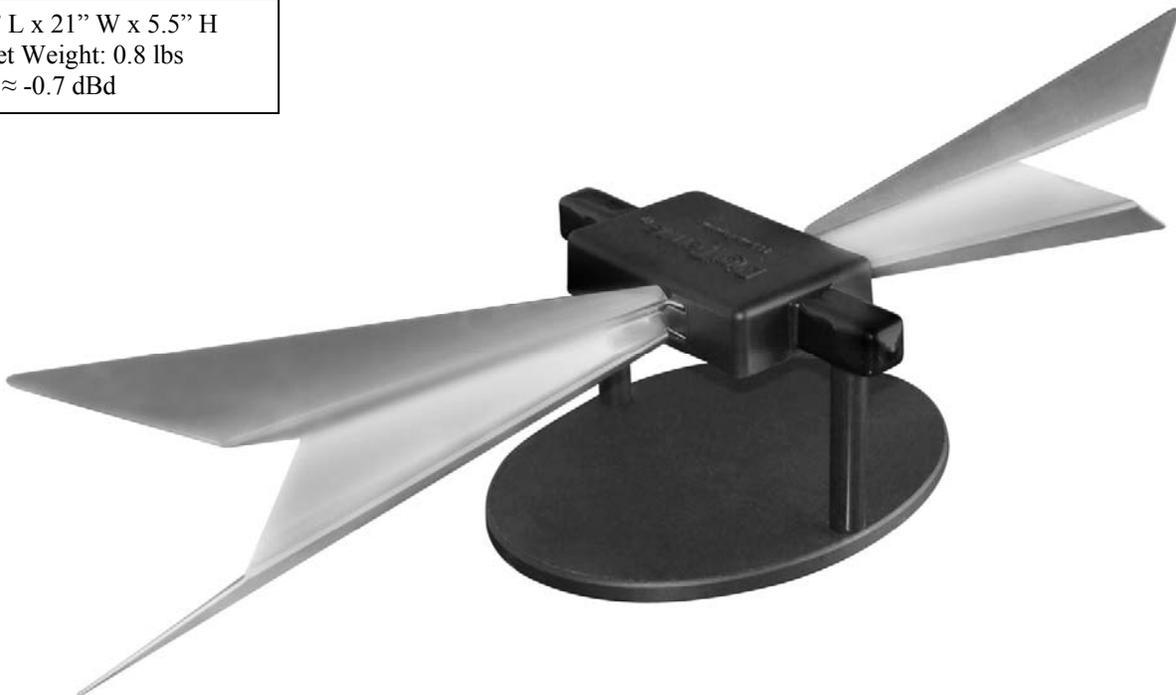
7" L x 21" W x 5.5" H
Net Weight: 0.8 lbs
G ≈ -0.7 dBd

Figure A2-3b Digitenna **DUV-I** VHF/UHF bi-directional receive antenna used in indoor field test.

Table 13 (later in this section) provides similar data as described above, except the tests were performed inside a building with a bi-directional consumer DUV-I indoor antenna mounted on a 5' high tripod. The two sets of measured indoor data reflect the difference in reception and margin between a horizontally-polarized and vertically-polarized receive antenna, therefore providing information about the amount of any de-polarization (if any) that might have occurred for the horizontally-polarized transmitted signal due to non-line-of-sight propagation conditions.

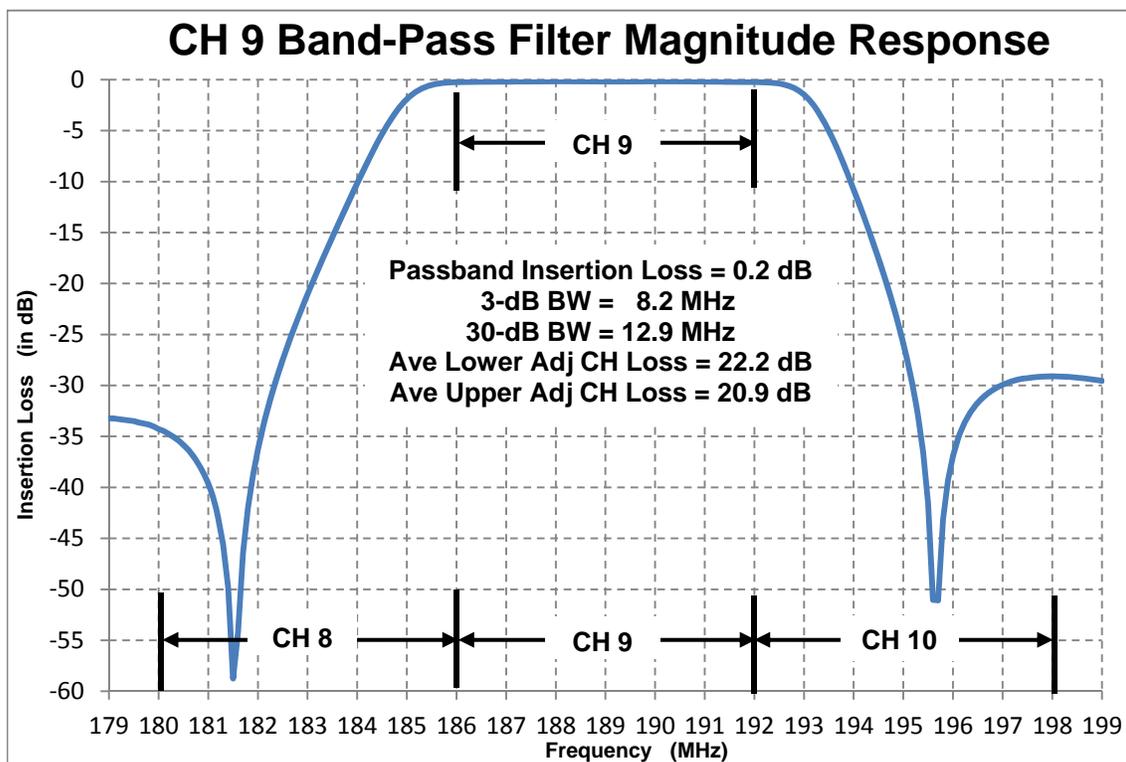
Figure A2-4b ETRI CH 9 band-pass filter magnitude response.

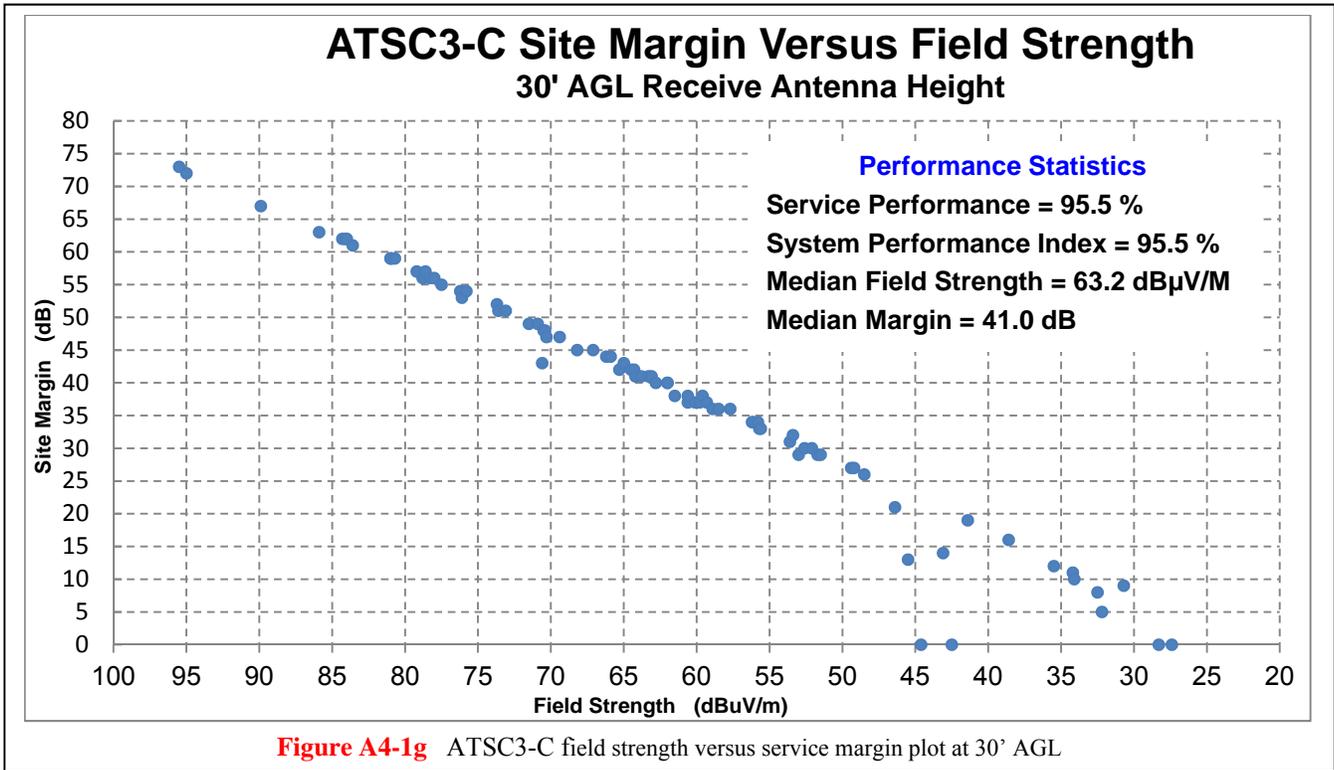
Figure A4-1g ATSC3-C field strength versus service margin plot at 30' AGL

With some exceptions, the field strength and margin values decrease with increased distance and lower receive antenna heights. The exceptions can be typically caused by differences in terrain and local propagation “clutter” as well as the fact that some distance groups only have 4 or 5 samples in them and therefore do not provide good statistical results.

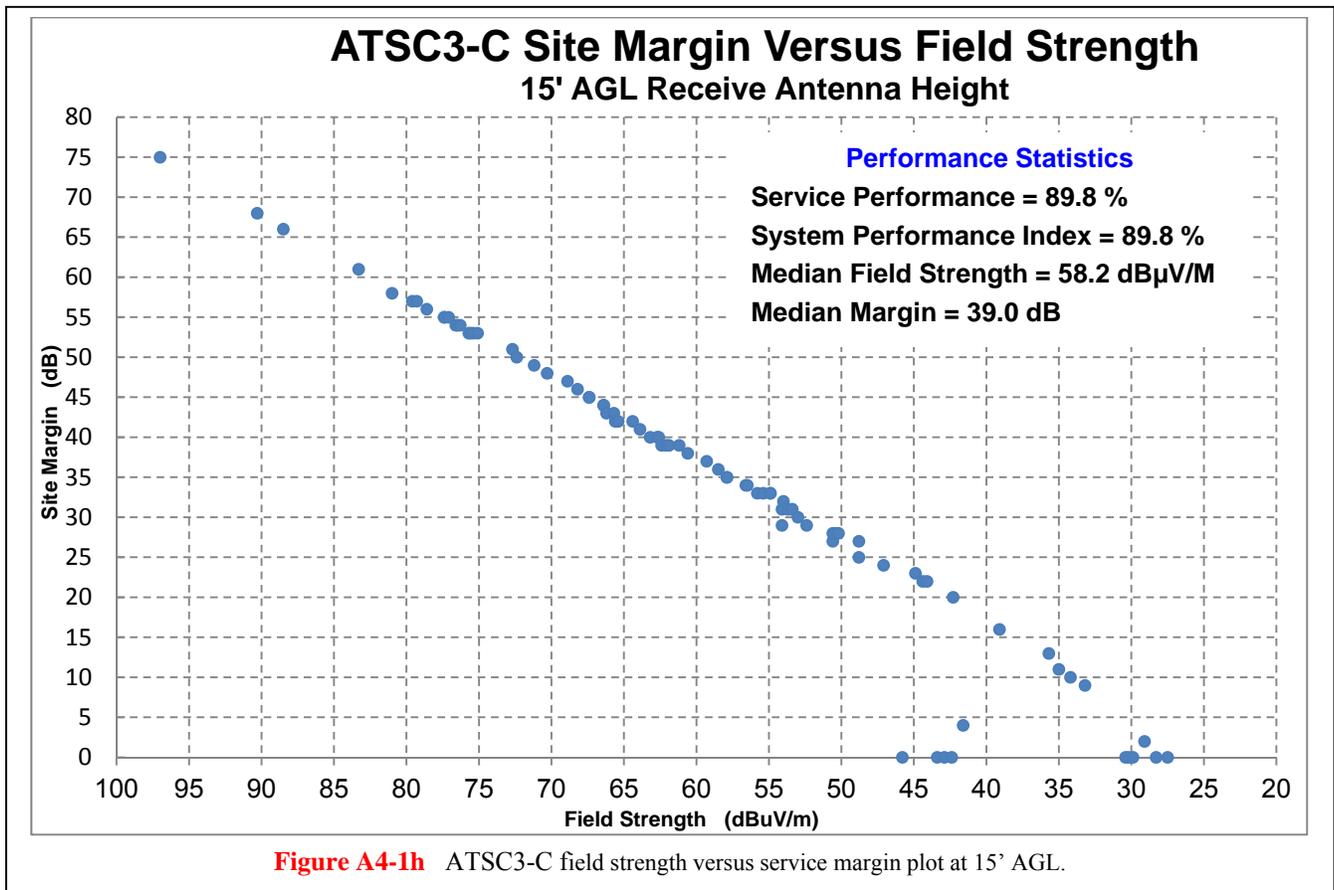
Figure A4-1h ATSC3-C field strength versus service margin plot at 15' AGL.

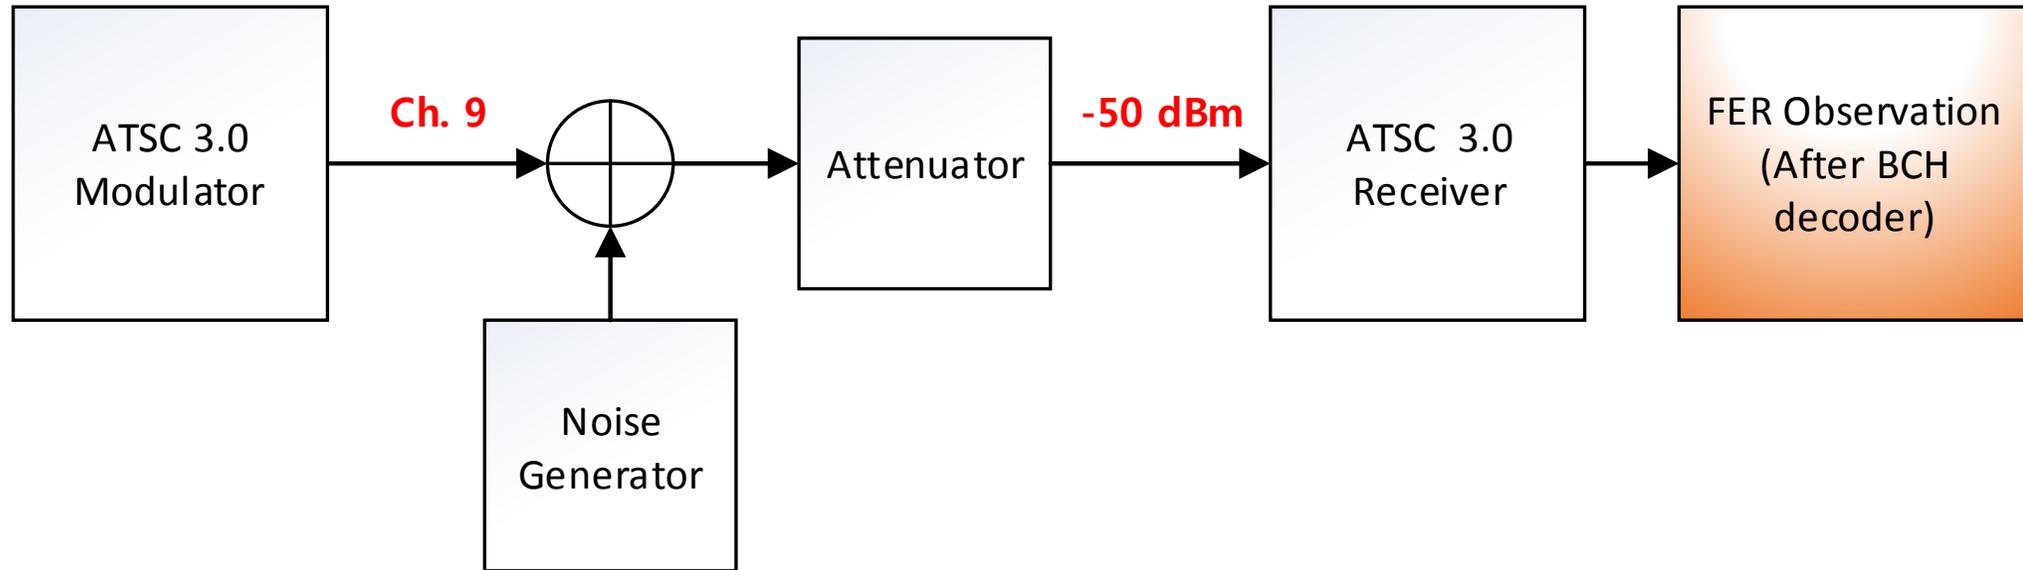
Laboratory Test Set-up

- ◆ Transmission channel: Ch. 9 (189 MHz)
- ◆ Rx power: -50 dBm (moderate)
- ◆ CNR Measurement step: 0.1 dB
- ◆ Measurement error due to fluctuation of signal and noise power → at least ± 0.1 dB error
- ◆ Target FER = 10^{-4}

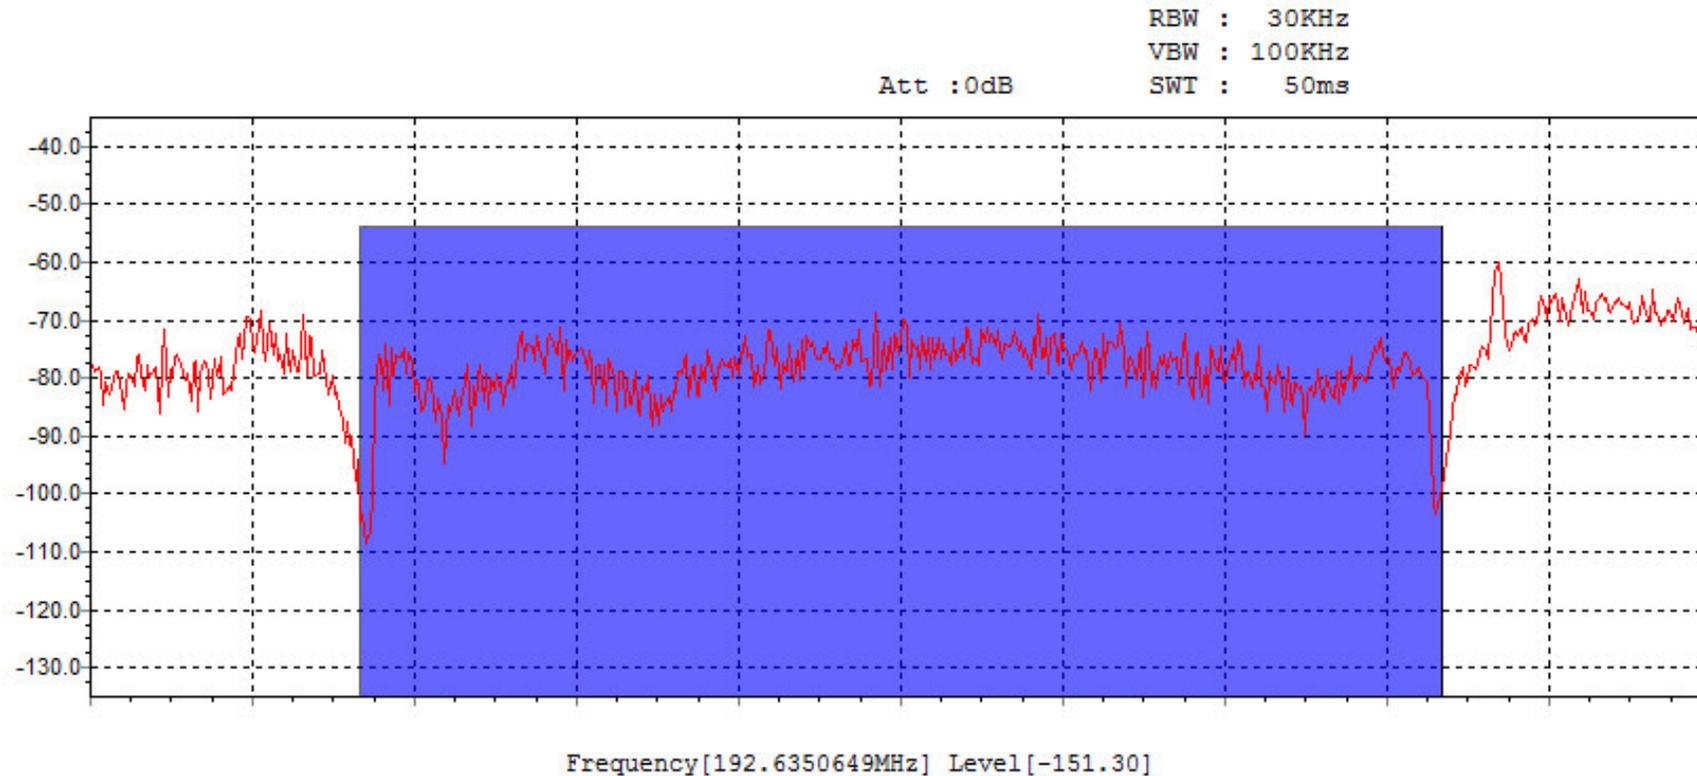
Good Mobile Reception: Example

NO	DATETIME	Logitude	Latitude	Level	EFS	TotalFrame	ErrorFrame	SNR
4697	2016-01-29 05:28:58	81.875677	41.422732	-53.92	68.83	50	0	25.1

Rx. Power = -53.9 dBm
Measured SNR in ETRI Rx = 25 dB

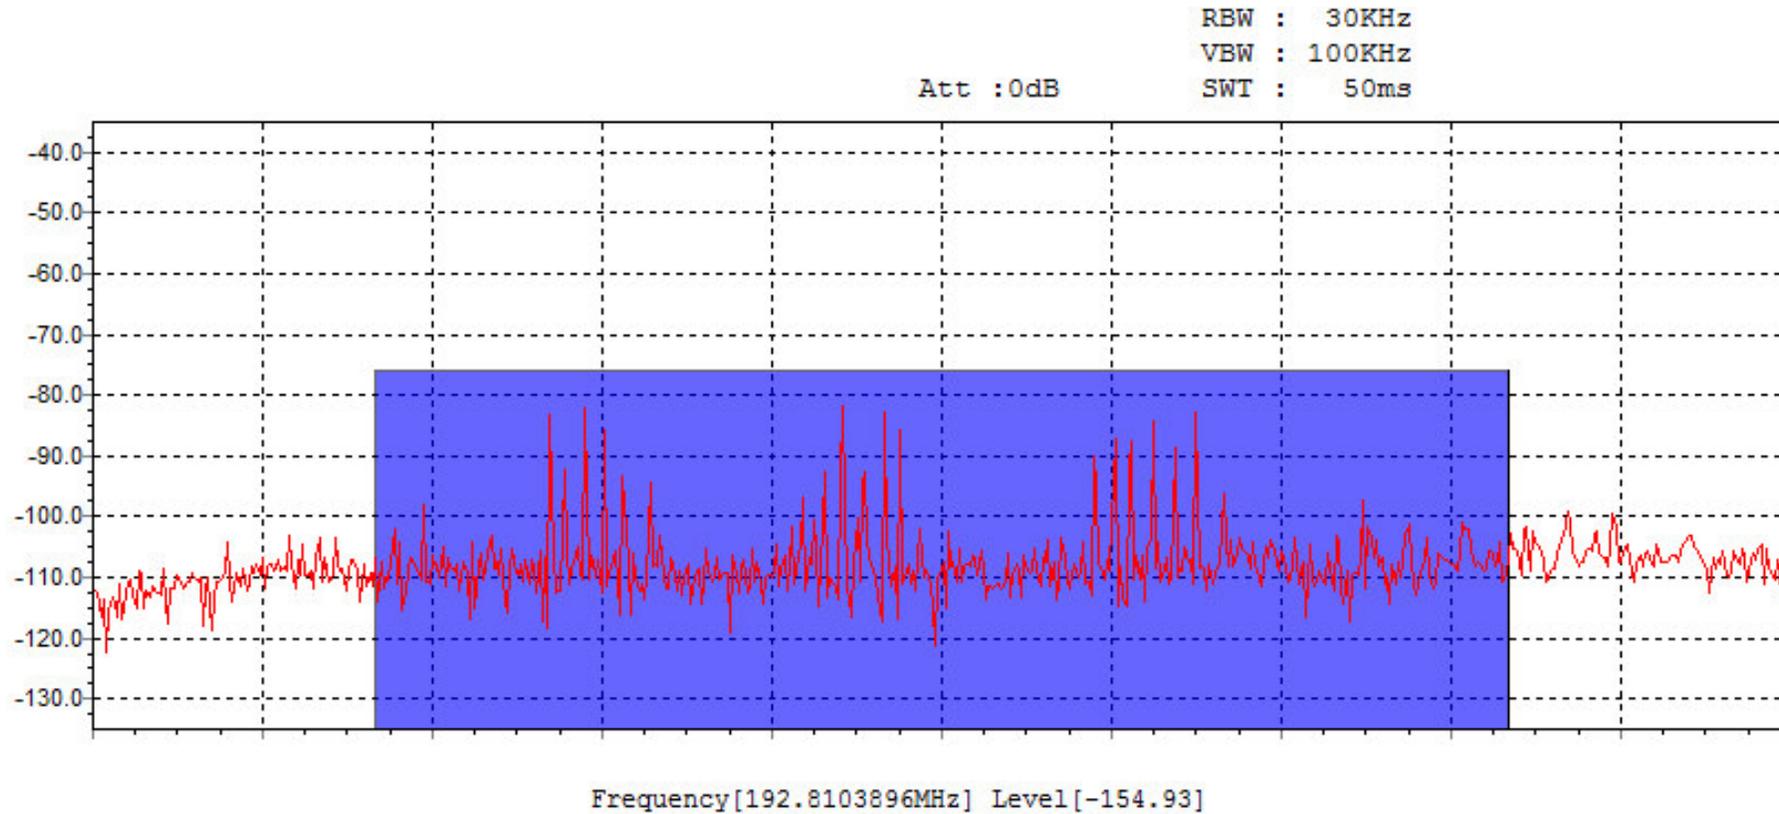
Unknown Impulse Noise

Unknown impulse noise was observed in one place
